Periodic Inspection of Jetties at Manasquan Inlet, New Jersey

Armor Unit Monitoring for Period 1994-1998

*by Robert R. Bottin, Jr., WES
William F. Rothert, Philadelphia District*

Final report

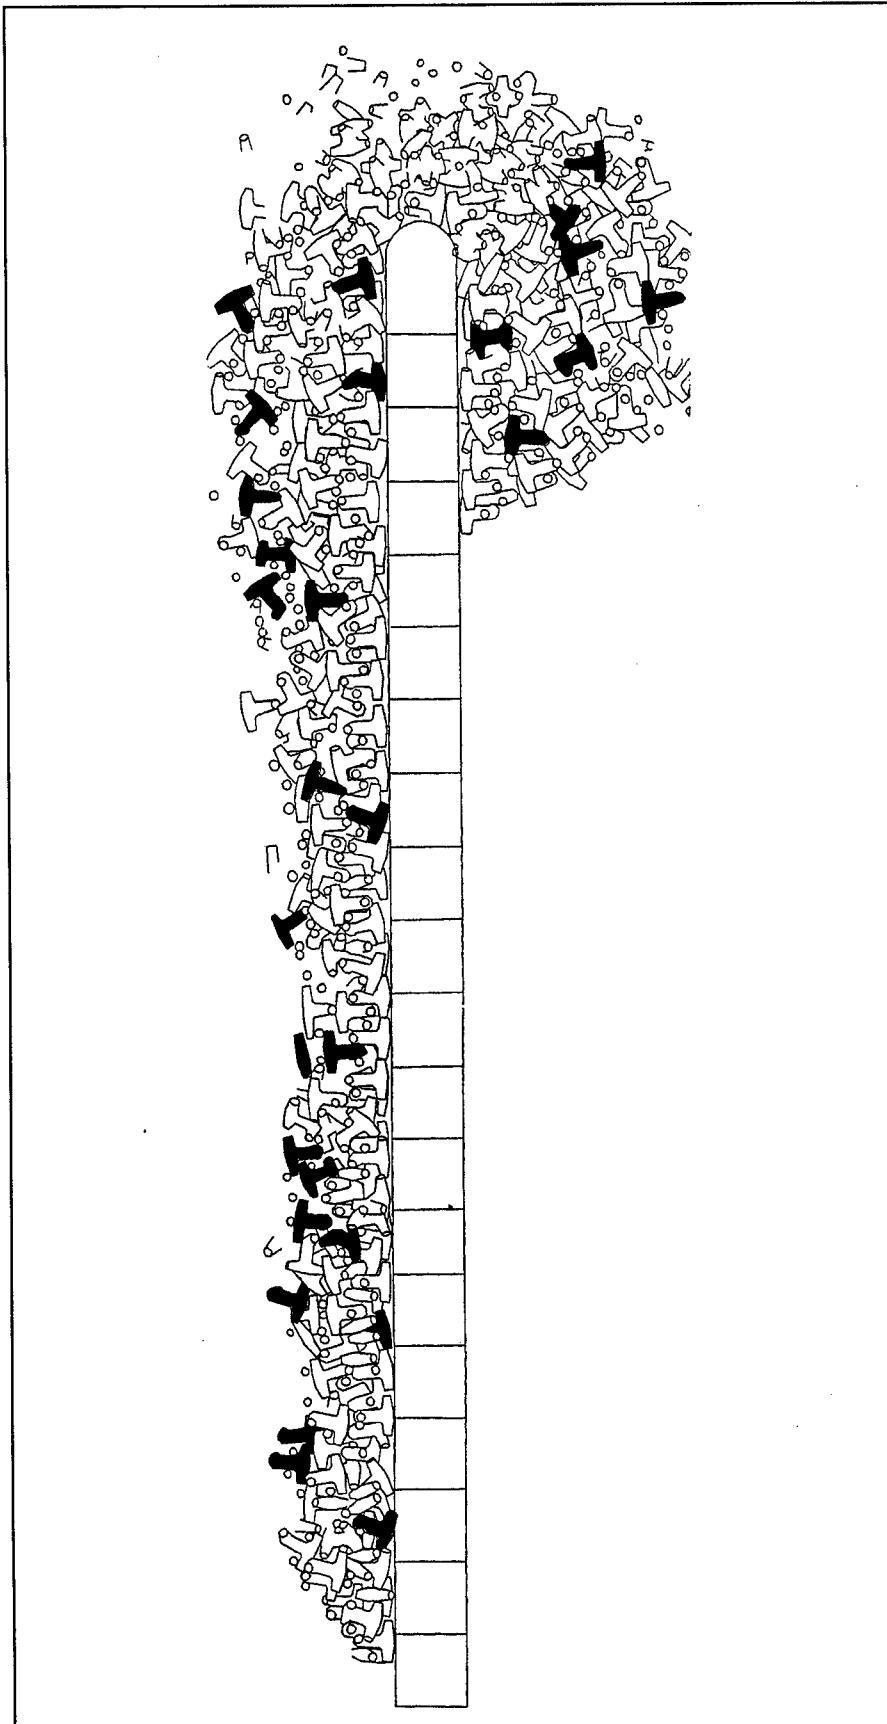
In addition to the targeted armor units, additional (nontargeted) dolosse were selected on the north and south jetties for comparison of movement data between the 1994 and 1998 surveys. The locations of these additional armor units are shown in Figures 29 and 30. Thirty-three dolosse on the north and 29 on the south jetty were selected. Outlines of these additional dolosse, as well as elevations at two or three points on each unit, were obtained from the stereo models for the two surveys and compared on photogrammetric maps to determine horizontal and vertical motions, similar to the procedures used on the targeted units.

Evaluation of the horizontal motions of the additional dolosse indicated that movement was relatively uniform for over half of the armor units, in that the entire unit tended to move in the same direction (nonrotational movement). Forty-five percent of the dolosse on the north jetty and 32 percent of those on the south jetty slightly rotated in either a clockwise or counterclockwise direction. Considering the rotated armor units, there was a dominance of clockwise rotation on the north jetty, and counterclockwise rotation was dominate on the south jetty. In general, of the additional (nontargeted) armor units analyzed that

Figure 30. Nontargeted dolosse armor units selected for analysis on south jetty
